RESULTS OF THE
THIRD SATURN I LAUNCH VEHICLE
TEST FLIGHT

MPR-SAT-63-3

RESULTS OF THE THIRD SATURN I LAUNCH VEHICLE TEST FLIGHT

The results of the Saturn I SA-3 test flight are presented in this report which represents the early engineering evaluation. The performance of each major vehicle system is discussed with special emphasis on malfunctions and deviations.

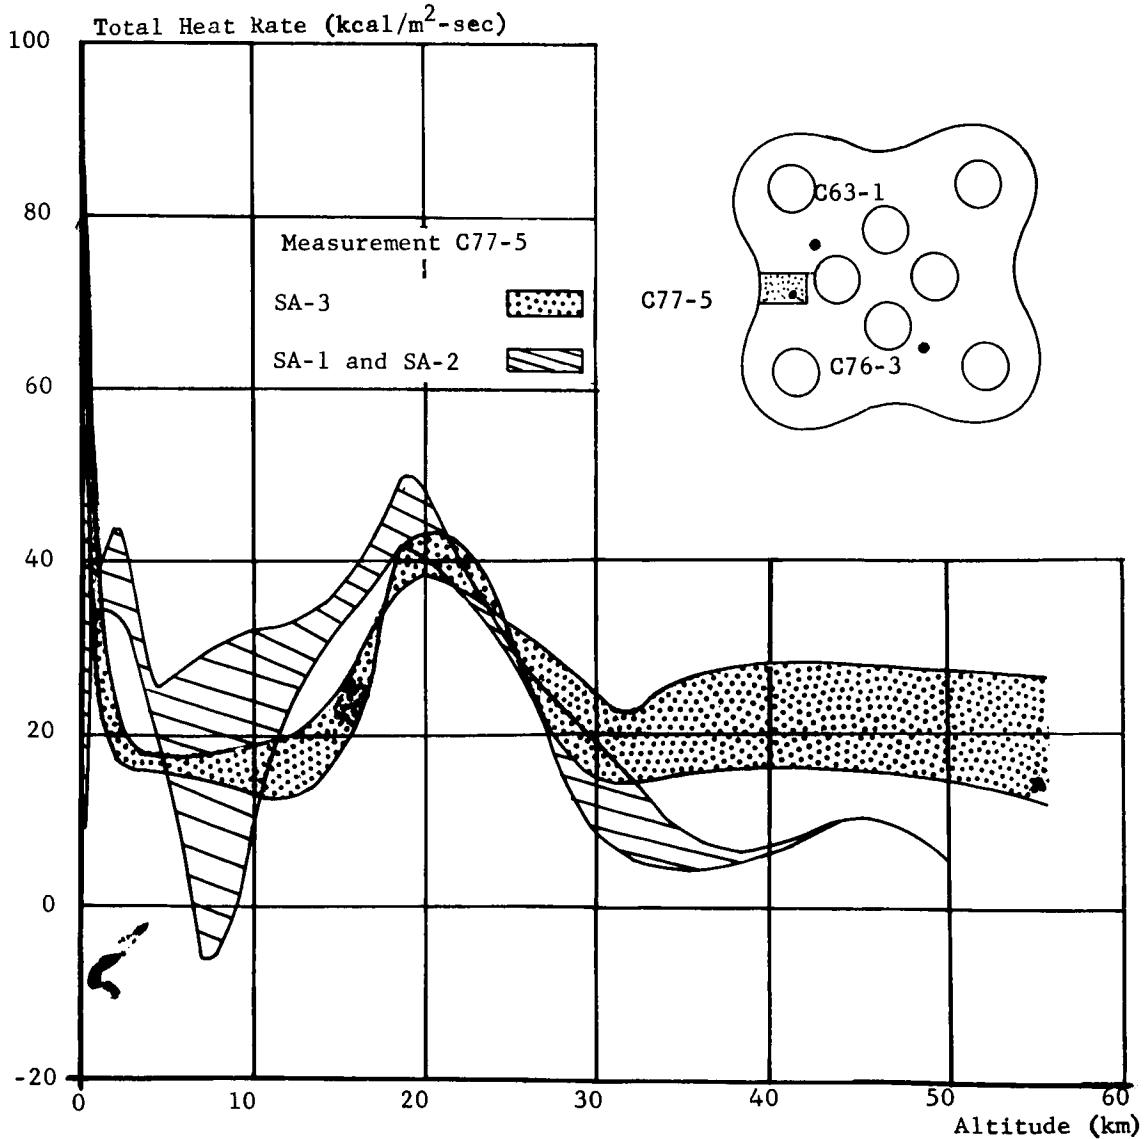
The total heat flux measured by C77-5, the calorimeter mounted flush with the panel insulated with M-31, is shown in Figure 51. With the exception of a high transient just after liftoff, the SA-3 heat flux in this area agrees, as expected, with SA-1 and SA-2 heat flux up to 32 kilometers. The relatively wide heat flux band from 32 km to cutoff is the result of applying two independent calibration techniques. One technique considers only the temperature-time decay following cutoff for the determination of the calorimeter loss coefficient to be applied throughout flight. The other technique utilizes a laboratory calibration method to determine the inflight corrections.

FIGURE 51. TOTAL HEAT RATE TO M-31 PANEL COMPARED TO SA-1 AND SA-2 RATES

This particular calorimeter, even though it showed almost identical efficiency as calorimeters C76-3 and C63-1 in laboratory calibration, had a loss after cutoff (based on the temperature-time history) of almost twice the rate encountered on C76-3, C63-1, or on previous flights' total calorimeter measurements (see illustration below).

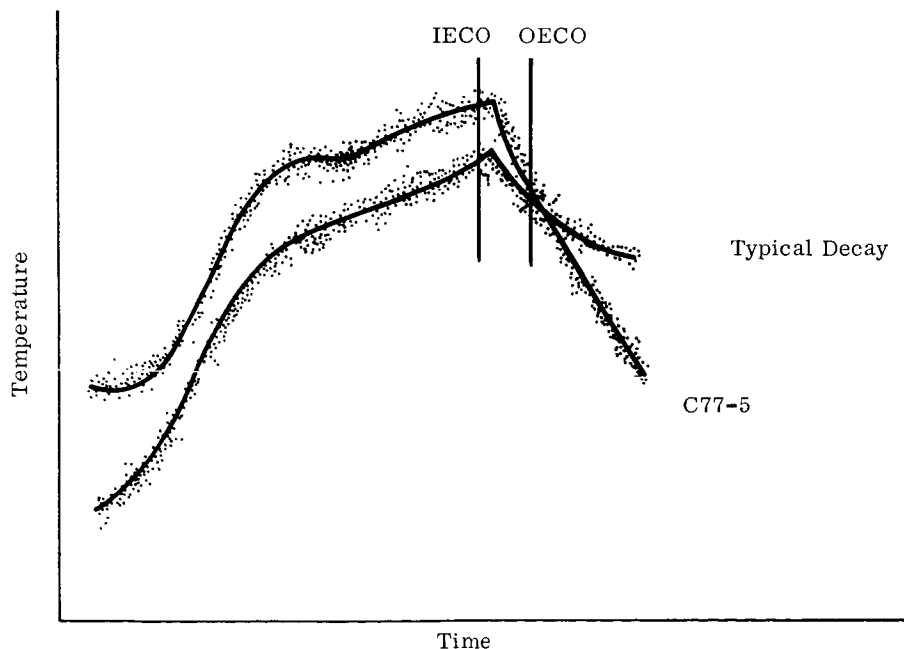
COMPARISON OF CUTOFF DECAY FOR C77-5 WITH A TYPICAL DECAY

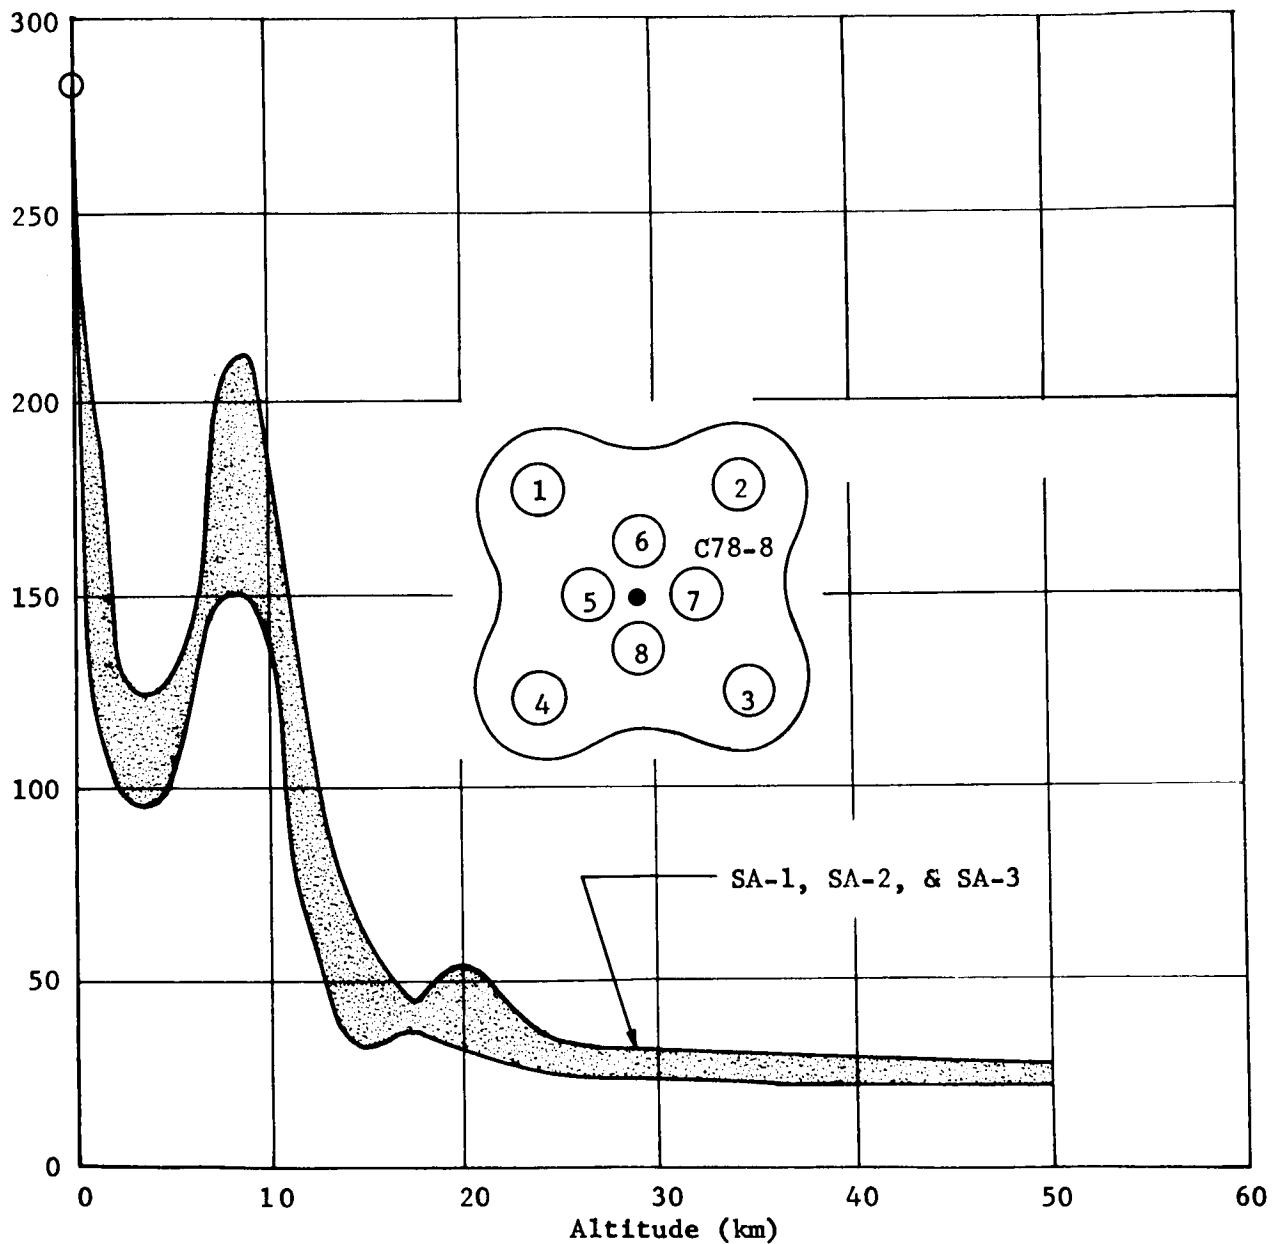
The total heat flux measured by the flame shield calorimeter C78-8 is shown in Figure 52. The SA-3 inflight heat flux to the flame shield is in good agreement with that measured during the SA-1 and SA-2 flights and absolute values are considered valid. The

FIGURE - 52. TOTAL HEATING RATE ON FLAME SHIELD, SA-1, SA-2 & SA-3

maximum heat flux measured near liftoff on SA-3 was slightly higher than that of SA-1 or SA-2. The heat flux measured at approximately 8 km (the altitude where the heat flux appears to be most strongly influenced by exhaust jet flow reversal) was slightly lower on SA-3 than on SA-1 or SA-2. Beyond approximately 25 km until IECO, the heat flux remained relatively constant.

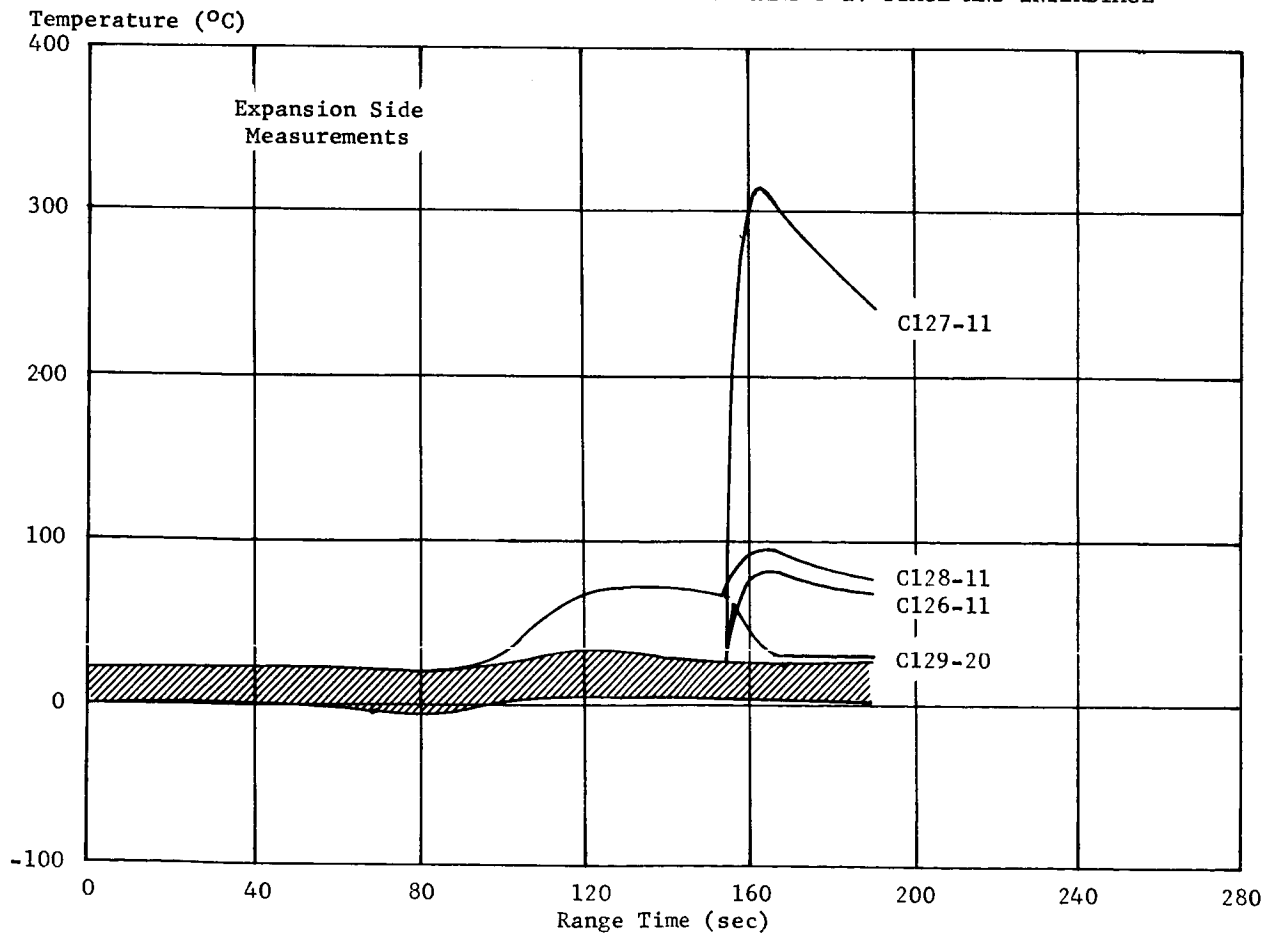
FIGURE 60. TEMPERATURE MEASUREMENT ON DUMMY S-IV STAGE AND INTERSTAGE

The retro rockets were ignited at approximately 153 sec range time and the response due to the heating from the retro rockets' plume impingement is shown in Figures 59 and 60. Measurement C127-11 (Figure 60) indicated the maximum temperature increase during retro rocket firing (from 10° C at 154 sec to 315° C at 161 sec). An investigation is being made to determine any secondary effects (thermocouple attachment, nearby structural members, etc.) that may have prevented an indication of the actual skin temperatures.

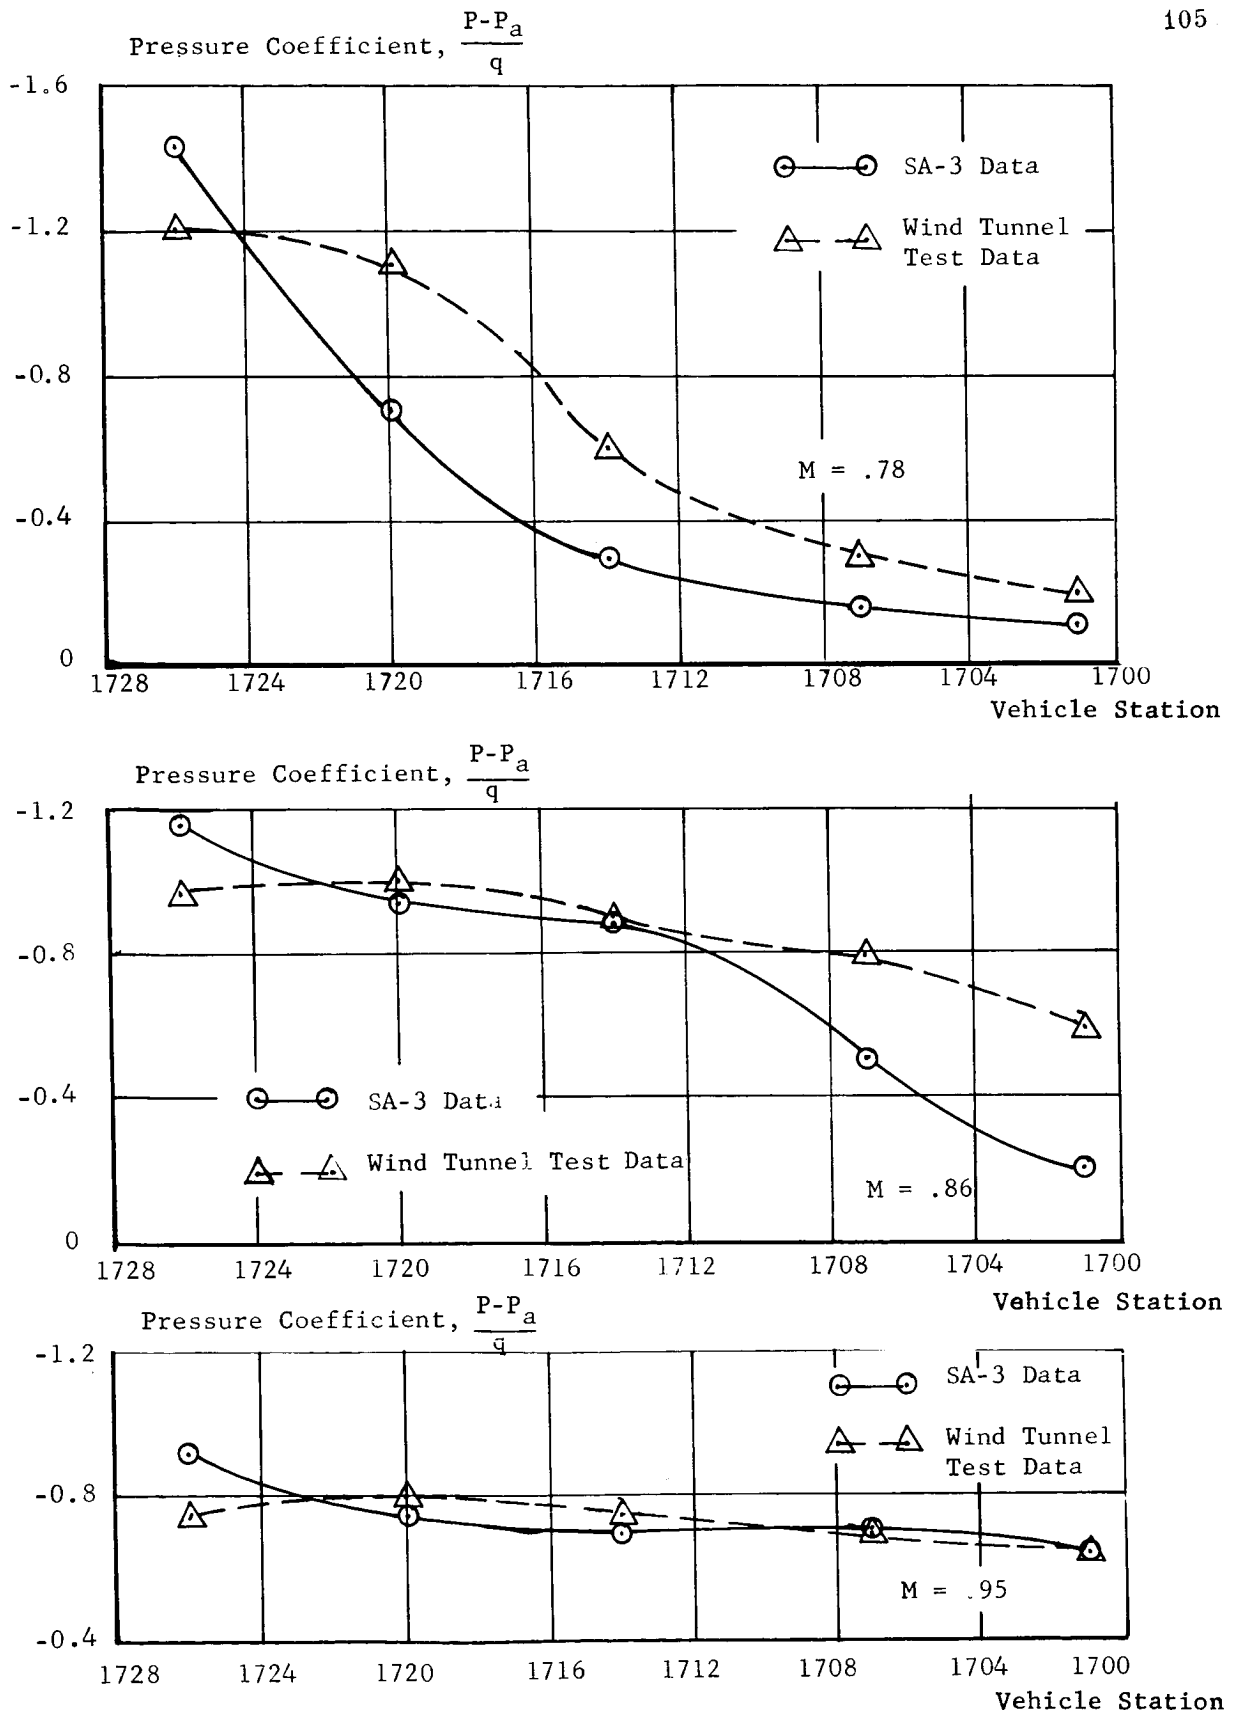
Values of pressure coefficients at various Mach numbers are plotted versus vehicle station in Figure 67. Results show excellent agreement with wind tunnel results (Reference 4) on the Centaur shoulder configuration tests at Ames Research Center for the Mach numbers available. The flight results indicate a very low pressure region right behind the shoulder in the subsonic region.

FIGURE 67. PRESSURE COEFFICIENT VERSUS VEHICLE STATION AT VARIOUS MACH NUMBERS ON CENTAUR-SIMULATION PANEL
